**Flood Control Project Maintenance
Levee Inspections**
LMA District Cover Sheet
Spring 2019 Levee Inspection Results

Reclamation District No. 2075 McMullin

Spring 2019 Levee Inspection Results

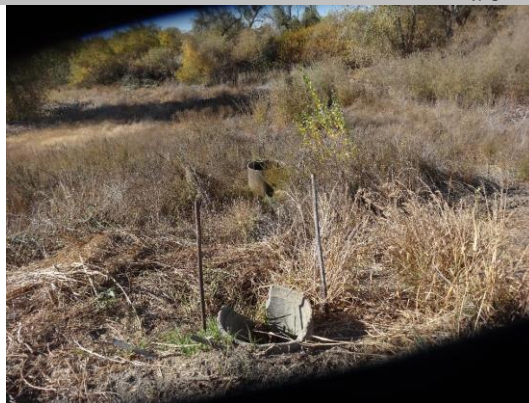
Photo 1 of 3 : UCIP_SP_2019_24663_44022.jpg

Comment Code					
Inspector Comment					
FS_ID:24663 DS_ID:24735 EP_NO: 4736 Repair Type: Non-Urgent Crossing Status: Found UCIP Comments: - pipe not visible on waterside.- no access to concrete riser on waterside.- blocked siphon breaker. FIELD_STRUCT_DESC: 14-inch coated steel drainage discharge pipe through the levee, 4 feet below the crown. Two concrete cutoff walls. Pump mounted on a pile structure in the drainage ditch on the landside (LS). Siphon breaker in a concrete riser on the waterside (WS) slope. Concrete distribution box at the WS toe. (Plans for removing and replacing an existing drainage pipe through the levee authorized under Permit No. 4736, 1964 - Reclamation District No. 2075). [Additional Reference(s): DWR Levee Log, 2005, 12-inch pipe referenced. USACE San Joaquin O&M Manual 3, December 1968, (HLM 0.12), 12-inch pipe referenced]. FS Date: 11/13/2013

WS view: concrete standpipe (top) and concrete pipe riser (bottom) on levee slope.

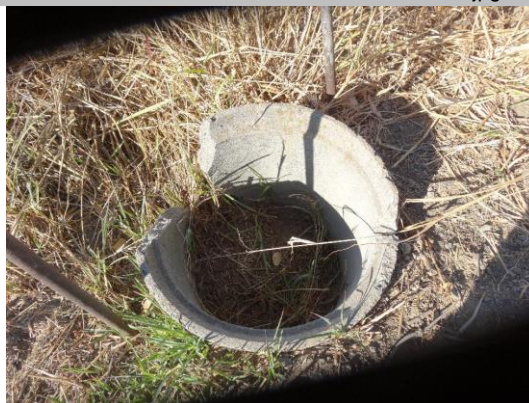
Photo 2 of 3 : UCIP_SP_2019_24663_44021.jpg

WS view: concrete pipe riser with siphon breaker on levee slope.

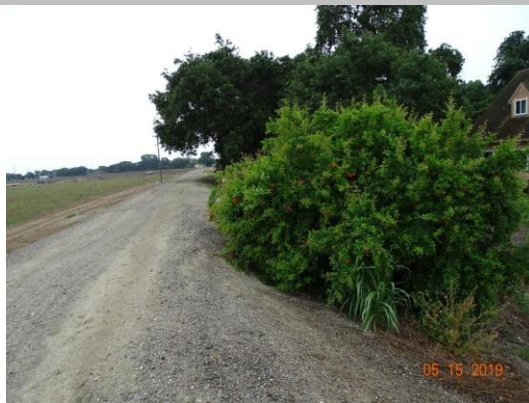
Photo 1 of 1 : SP_2019_RD2075_315_25_20190520_00065.jpg

View of landscape bush on waterside slope in front of residential home. (Spring 2019)

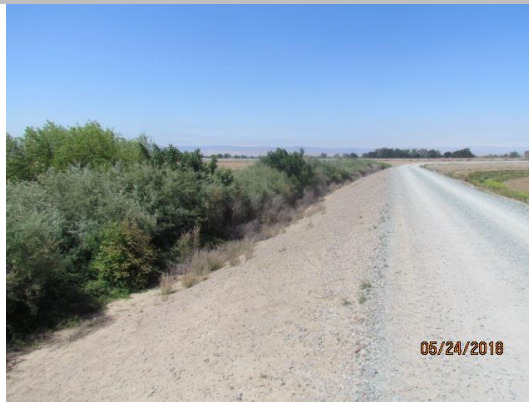
Photo 1 of 3 : SP_2019_RD2075_315_29_20190313_00040.jpg

Looking west at dense veg at landward toe. (Spring 2018)

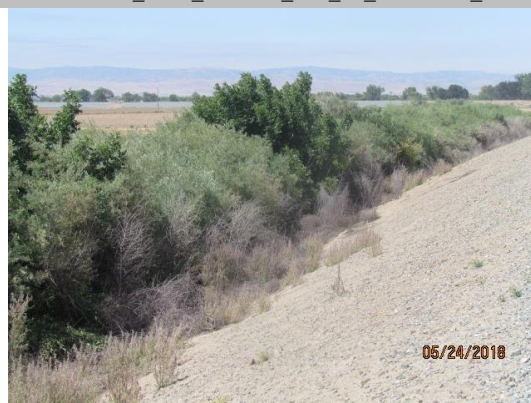
Photo 2 of 3 : SP_2019_RD2075_315_29_20190313_00041.jpg

Looking west at dense veg. at landward toe. (Spring 2018)

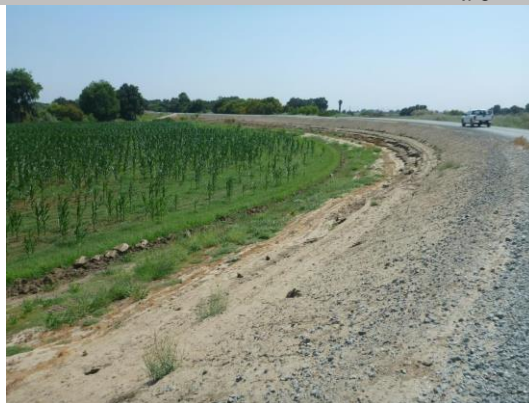
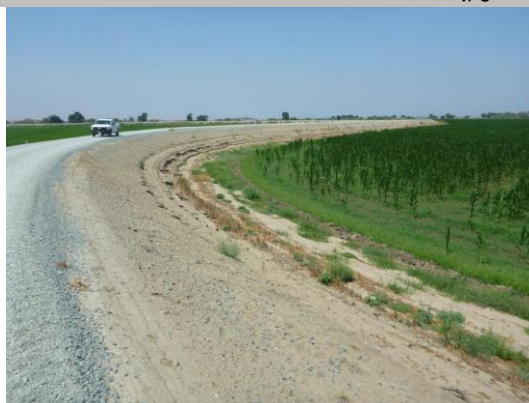
Description: Slope protection repairs are needed along the waterside slope due to erosion and riprap displacement from high water. Based upon levee inspections, it was determined the waterside levee slope is eroding, deteriorating, and degrading. The eroded levee sections need to be restored back to design standards to prevent further deterioration and damage.

Notes: 10/23/17: According to LMA and my observations at LM 1.63, this site never had riprap (contrary to previous comments). Erosion has encroached into levee prism. Future high water and wavewash will likely advance erosion further into prism. Repairs should be made prior to next high water.

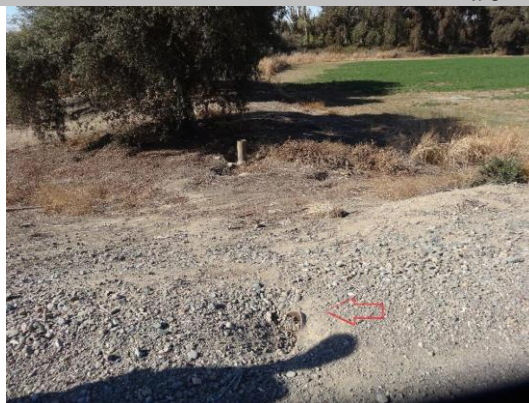
Photo 1 of 3 : UCIP_SP_2019_24666_45600.jpg

LM Start	2.32	Rating **	M	Issue No.	36
LM End	2.32	Issue Type +	Ma	Location *	
Category	Supplemental			GPS Latitude/Longitude	
				Start	End
Item	DWR UCIP LMA Responsibility			37.731314 °	37.731314 °
				-121.293713 °	-121.293713 °
DWR ID	24737				
Comment Code					
Inspector Comment					
FS_ID:24666 DS_ID:24737 EP_NO: N/A Repair Type: Non-Urgent Crossing Status: Found UCIP Comments: - service pole on landside.- looks abandoned. Walkway in dilapidated condition. FIELD_STRUCT_DESC: 16-inch steel drainage discharge pipe through the levee, 4.5 feet below the crown. Corrugated metal cutoff wall. Pump mounted on a pile structure in a drainage ditch on the landside (LS). Siphon breaker in a corrugated metal pipe (CMP) riser on the waterside (WS) slope. [Additional Reference(s): DWR Levee Log, 2005. USACE San Joaquin O&M Manual 3, December 1968, (HLM 2.30)]. FS Date: 11/13/2013

WS view: concrete standpipe (top) and steel pipe riser (bottom marked) on levee slope.

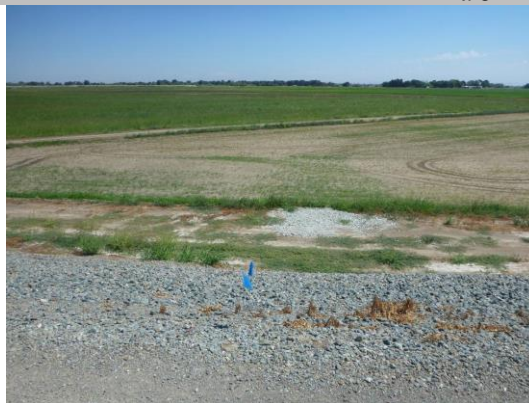
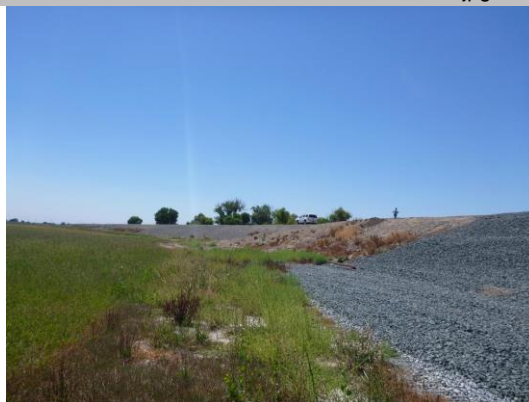
Description: Sinkholes have formed along the landside levee toe as a result of the high water. The cause of the sinkholes is not clear, but a similar phenomenon in this area is believed to have caused the levee breach earlier this year. Further geotechnical investigation is needed.

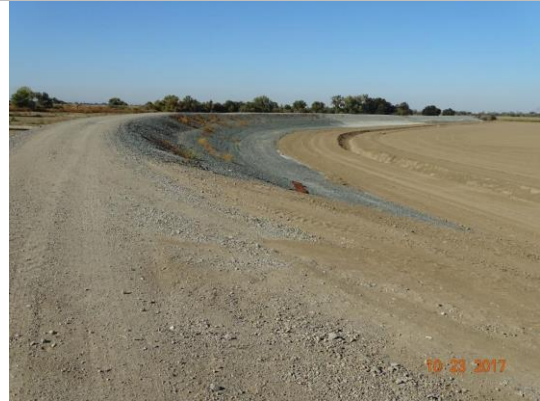
Photo 3 of 3 : SP_2019_RD2075_315_15_20190313_00016.jpg

Comment Code					
Inspector Comment					
Levee Evaluation Comments					
Description:Sinkholes have formed along the landside levee toe as a result of the high water. The cause of the sinkholes is not clear, but a similar phenomenon in this area is believed to have caused the levee breach earlier this year. Further geotechnical investigation is needed.					
Site ID No:479					
Site Designation:LMA-306					
Repair Type: Stability					
Rating:Area of Concern					
Field Date:7/26/2017					
Notes: Sink holes appear to have already been filled. 10/23/17: LMA has removed pipes (parallel to levee) in this area, and drainage ditch has been relocated to approx 60 feet away from levee toe. Known sandy soils in region may contribute to sinkholes.

10/23/17: LMA has removed pipes (parallel to levee) in this area, and drainage ditch has been relocated to approx 60 feet away from levee toe. Known sandy soils in region may contribute to sinkholes.

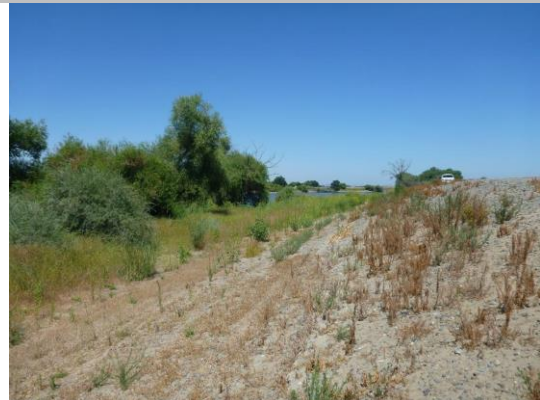
Comment Code					
Inspector Comment					
Levee Evaluation Comments					
Description:Slope protection repairs are needed along the waterside slope due to erosion. Based upon levee inspections, it was determined the waterside levee slopes were eroding, deteriorating and degrading in concave pocket sections at various locations along this levee reach. The eroded levee sections need to be restored back to design standards to prevent further deterioration of the damaged levee sections.					
Site ID No:480					
Site Designation:LMA-307					
Repair Type: Erosion					
Rating:Area of Concern					
Field Date:7/26/2017					
Notes: Low priority because of the wide berm. Could not see all of the bank because of vegetation. Rock was placed on LS here during this years (2017) storms.

Description: Slope protection repairs are needed along the waterside slope due to erosion. Based upon levee inspections, it was determined the waterside levee slopes were eroding, deteriorating and degrading in concave pocket sections at various locations along this levee reach. The eroded levee sections need to be restored back to design standards to prevent further deterioration of the damaged levee sections.

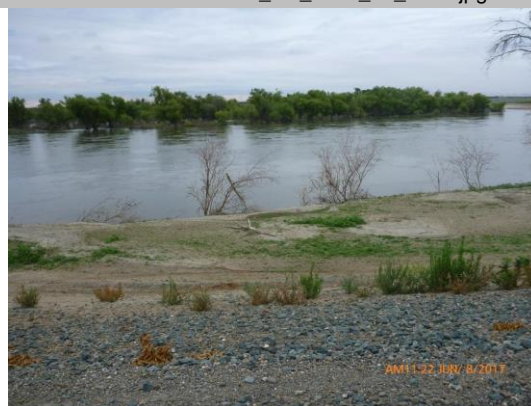
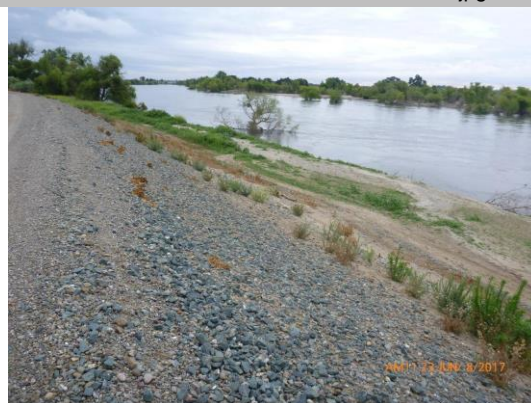
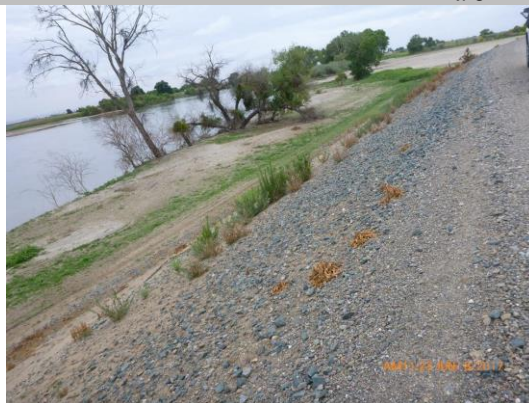
LM Start	2.77	Rating **	A/W	Issue No.	14
LM End	2.83	Issue Type +	Ma	Location *	WS
Category	Supplemental			GPS Latitude/Longitude	
				Start	End
Item	2017 Storm Damage			37.724810 °	37.724207 °
				-121.294150 °	-121.293308 °
DWR ID	DWR_RD2075_01_f_2017_14				
Comment Code					
Inspector Comment					
Levee Evaluation Comments					
Description:					
Site ID No:81					
Site Designation:LMA-35					
Repair Type: Erosion					
Rating:Area of Concern					
Field Date:6/8/2017					
Notes: no damage present 10/23/17: Photos taken of vertical eroded low-flow bank approximately 20 feet from waterside levee toe. Area is composed of loose sand. Sandbar in channel may direct current toward this area.

Notes: no damage present 10/23/17: Photos taken of vertical eroded low-flow bank approximately 20 feet from waterside levee toe. Area is composed of loose sand. Sandbar in channel may direct current toward this area.

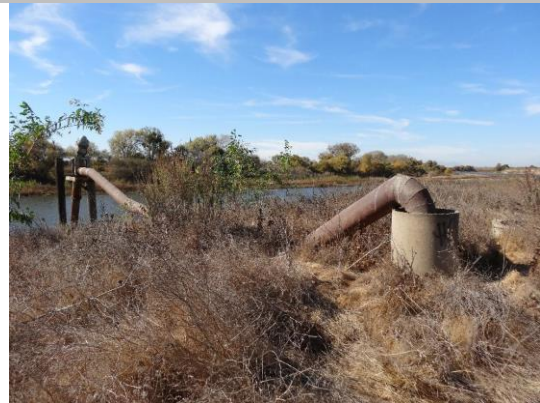
Photo 1 of 3 : UCIP_SP_2019_41721_45982.jpg

Comment Code					
Inspector Comment					
FS_ID:41721					
DS_ID:24746					
EP_NO: N/A					
Repair Type: Non-Urgent					
Crossing Status: Found					
UCIP Comments: Several concrete structure with Alfalfa valve. Only steel pipe visible on river bank. Service pole on waterside.New field discovered crossing.					
FIELD_STRUCT_DESC: 10-inch polyvinyl chloride (PVC) irrigation discharge pipe through the levee, at an unknown depth. Slant pump on the riverbank. Distribution box on the waterside (WS) berm. Concrete U-shaped headwall and open outlet on the landside (LS) toe. Crossing was field discovered. (Plans to install a slant pump on the riverbank authorized under Permit No. 5484, 1966 - Jack Clinton).					
FS Date: 11/13/2013

WS view: slant pump and concrete distribution box on levee berm.

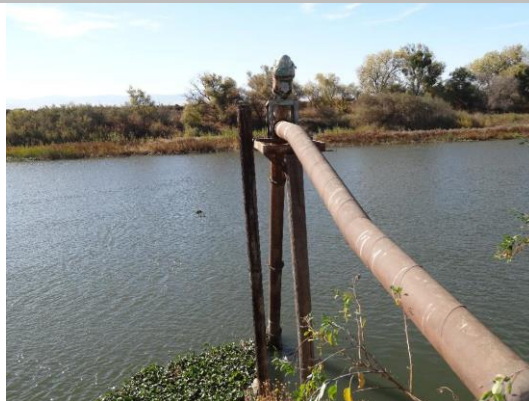
Photo 2 of 3 : UCIP_SP_2019_41721_45981.jpg

WS view: slant pump on timber pile in the stream.

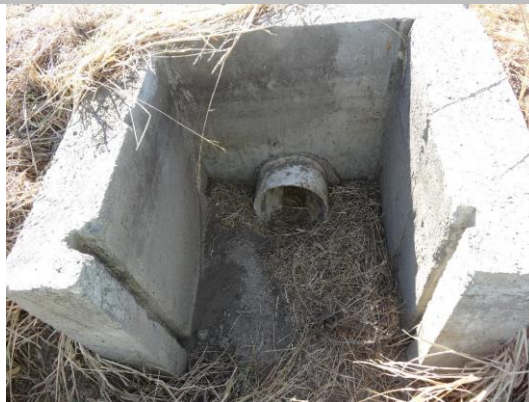
Photo 3 of 3 : UCIP_SP_2019_41721_45980.jpg

LS view: concrete U type headwall on levee toe and open PVC pipe.

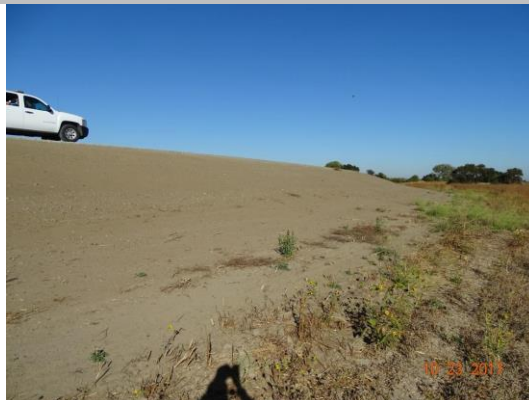
Photo 4 of 4 : SP_2019_RD2075_315_18_20190313_00023.jpg

10/23/17: There was no riprap in this area (contrary to previous comment). Erosion sites have been repaired by LMA.

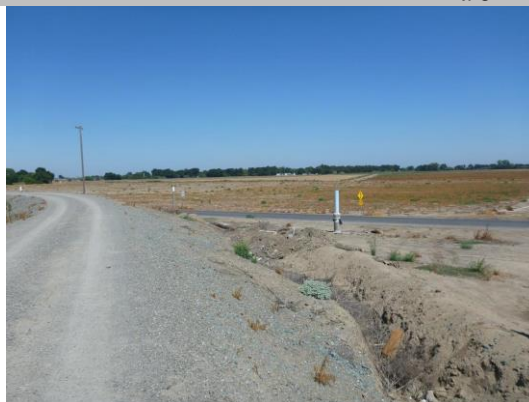
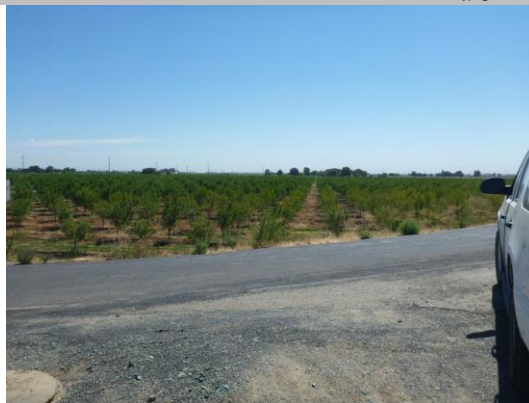
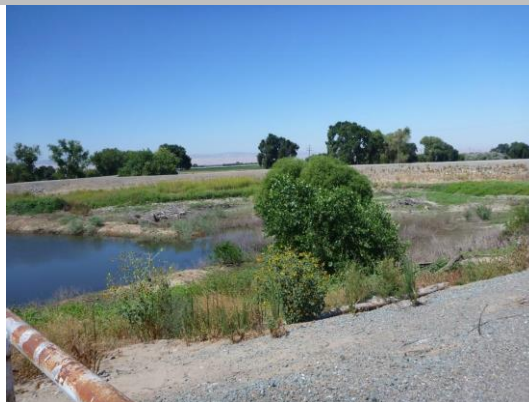
LM Start	4.95	Rating **	A/W	Issue No.	20
LM End	5.20	Issue Type +	Ob	Location *	LS
Category	Supplemental			GPS Latitude/Longitude	
				Start	End
Item	2017 Storm Damage			37.727200 °	37.728900 °
				-121.277800 °	-121.275200 °
DWR ID	DWR_RD2075_01_f_2017_20				
Comment Code					
Inspector Comment					
Levee Evaluation Comments					
Description:Heavy seepage was observed during the high water this year 2017.					
Site ID No:481					
Site Designation:LMA-308					
Repair Type: Seepage					
Rating:Area of Concern					
Field Date:7/26/2017					
Notes: No evidence of flood fight here, but the orchard trees next to the levee are looking a little yellow compared to the others.

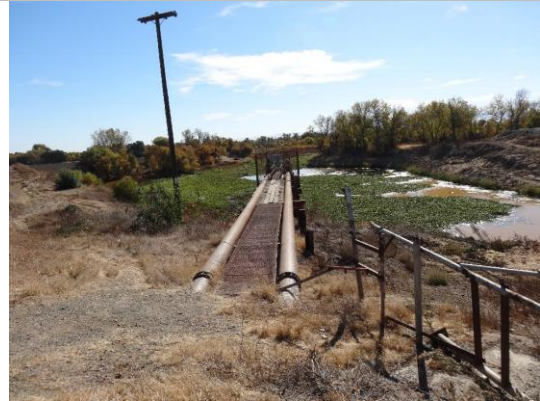
Photo 1 of 3 : UCIP_SP_2019_50209_45603.jpg

WS view: two pipes, walkway to pump and pile structure in the stream.

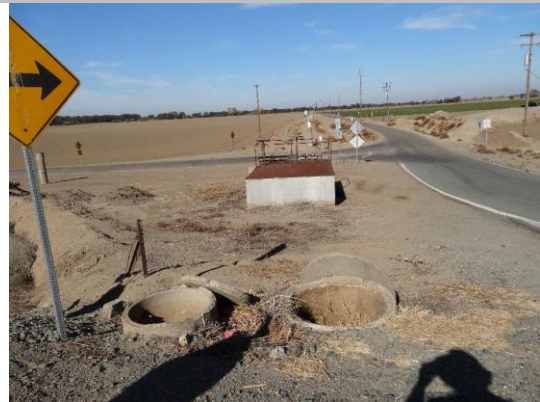
Photo 2 of 3 : UCIP_SP_2019_50209_45602.jpg

LS view: siphon breakers in concrete pipe risers (bottom) on levee slope. Concrete distribution box on levee toe (top).

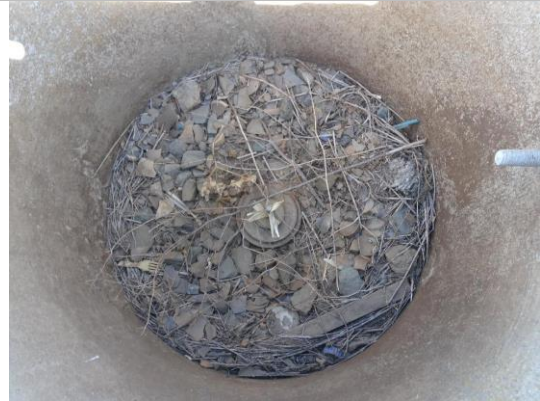
Photo 3 of 3 : UCIP_SP_2019_50209_45605.jpg

LS view: siphon breaker in concrete pipe riser on levee slope.

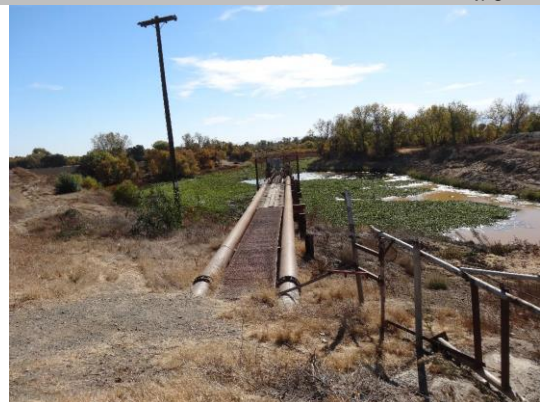
Photo 1 of 3 : UCIP_SP_2019_25184_45608.jpg

WS view: two pipes, walkway to pump and pile structure in the stream.

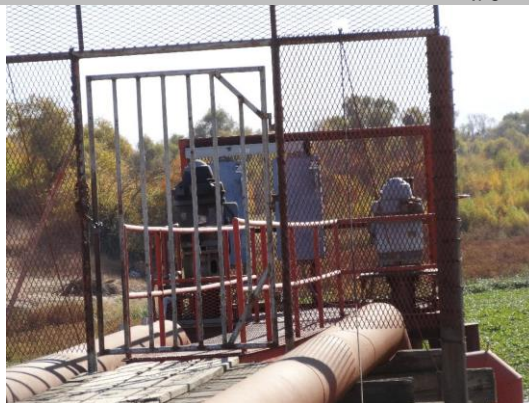
Photo 2 of 3 : UCIP_SP_2019_25184_45607.jpg

WS view: closer view of two pumps and platform in the stream.

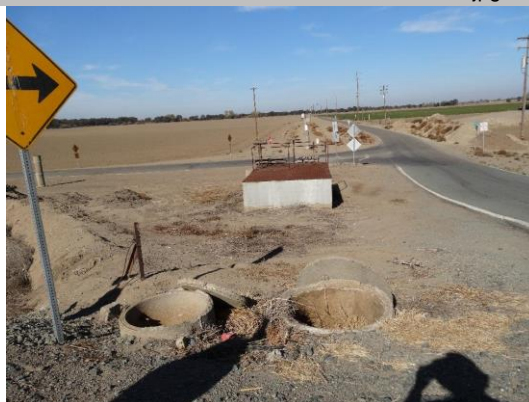
Photo 3 of 3 : UCIP_SP_2019_25184_45606.jpg

LS view: siphon breakers in concrete pipe risers (bottom) on levee slope. Concrete distribution box on levee toe (top).

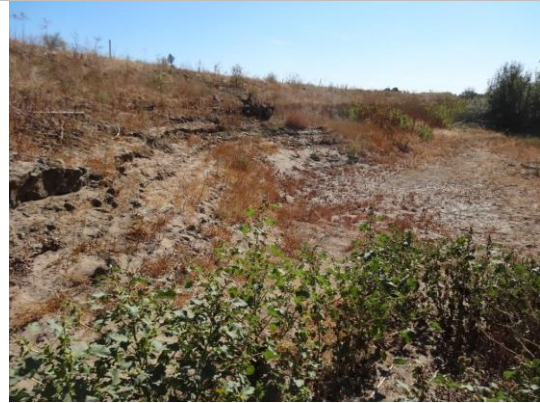
Photo 3 of 3 : SP_2019_RD2075_315_1_20190313_00003.jpg

Looking upstream at the site.

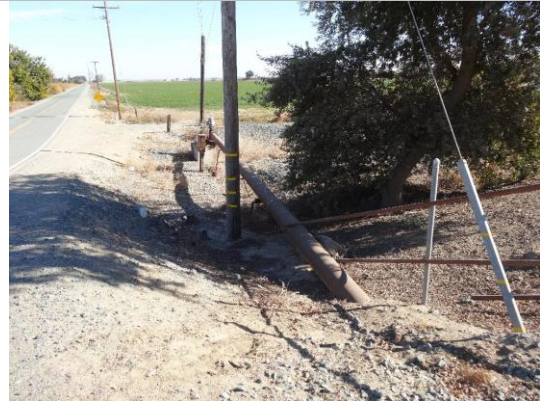
Photo 2 of 3 : UCIP_SP_2019_50191_44261.jpg

LS view: pipe, pump and concrete sump in the drain ditch.

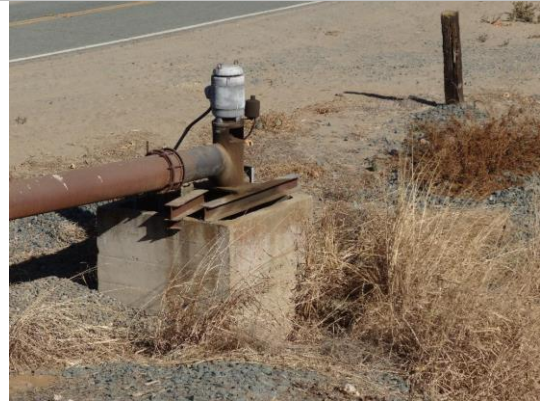
Photo 3 of 3 : UCIP_SP_2019_50191_44260.jpg

LS view: closer view of pipe, pump and concrete sump in the drain ditch.

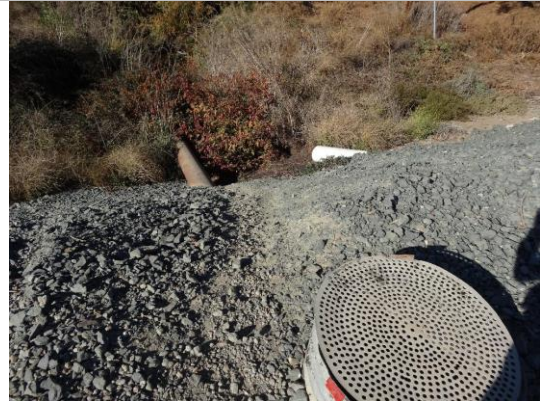
Photo 1 of 3 : UCIP_SP_2019_50213_45613.jpg

WS view: CMP riser (bottom) on levee shoulder. Steel pipe (top) and temporary pvc pipe on levee slope.
